Jon Batts v. Remington Arms Company, LLC

Expert Report – Firearm & Incident Analysis

Prepared by: Derek Watkins

Date: 07/15/2019

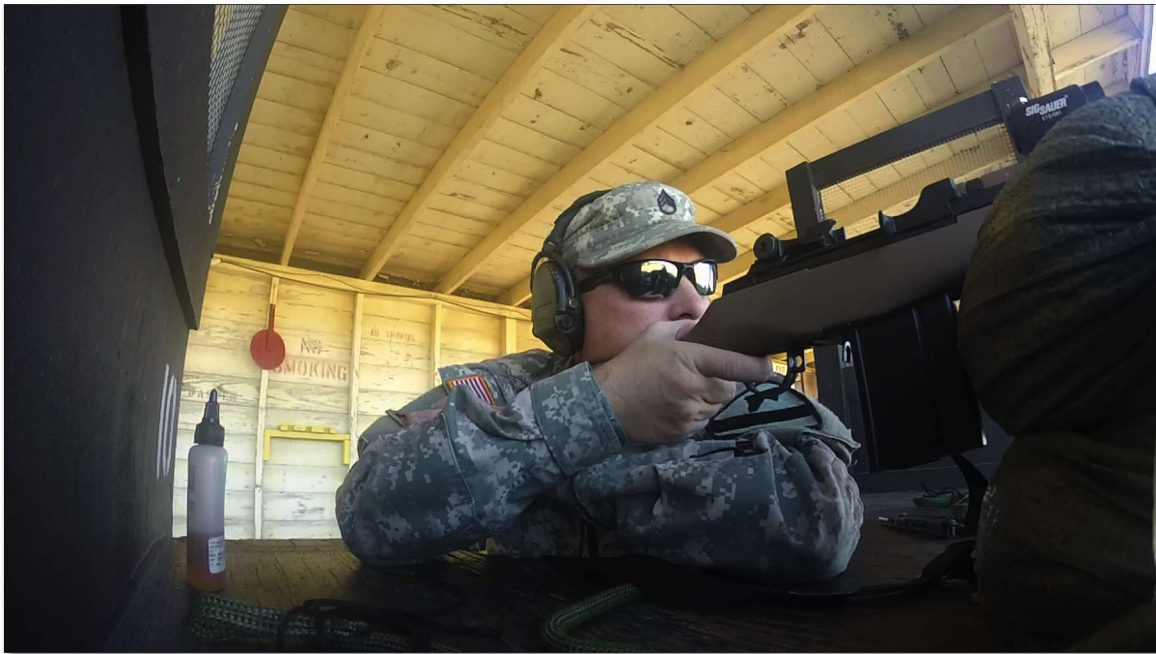
Figure 6.5: GOPR5586 Video Frame of Mr. Batts Firing his M1A Rifle

Video Gopr5586 shows Mr. Batts discharging his M1A rifle. See Figure 6.5. Video Gopr5586 also shows Mr. Batts is drawing cartridges from a reloader's ammo box². See Figure 6.6. Video Gopr5586 shows Mr. Batts shot seven rounds of 308 Win ammunition through his M1A. Mr. Batts then counts four columns of cartridges in his reloader's ammo box. Each column holds five cartridges, but the video shows the last column is missing two cartridges. Therefore, counting the seven shots Mr. Batts discharged, Mr. Batts brought 25 rounds of unfired 308 Win ammunition to the range with him on the day of the incident. The ammunition Mr. Batts was firing appears to be hand loads not only because of the box

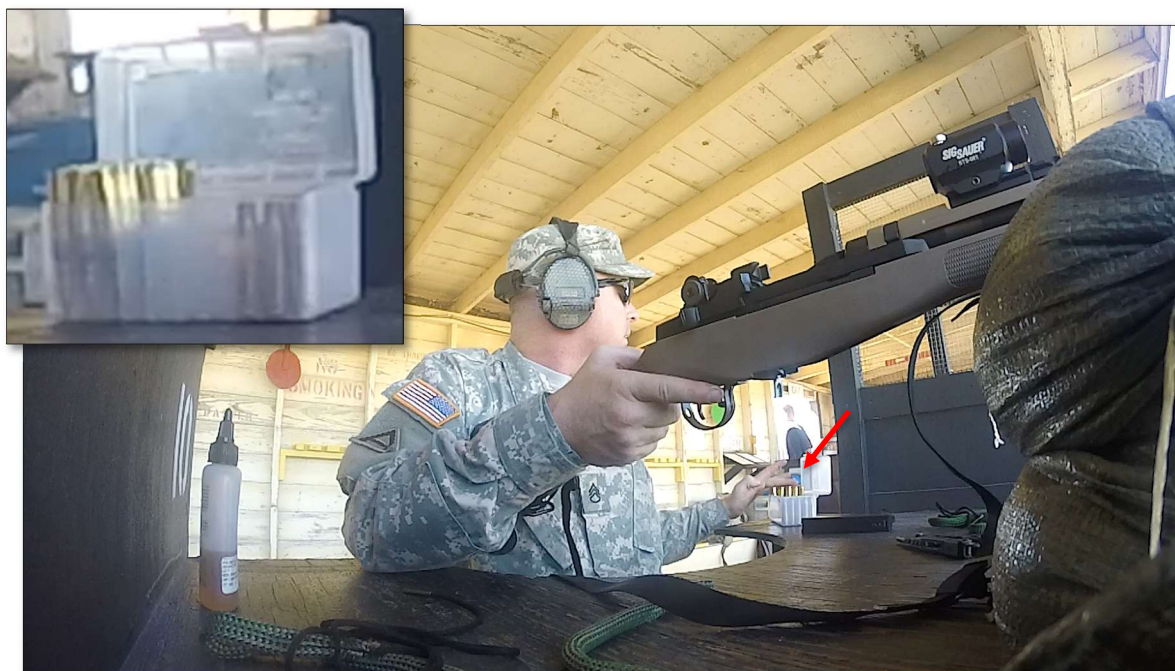
Figure 6.6: GOPR5586 Video Frame of Mr. Batts Counting Unfired 308 Win Cartridges

they were in, but also because commercial 308 Win ammunition is most often sold in boxes of 20, not 25.

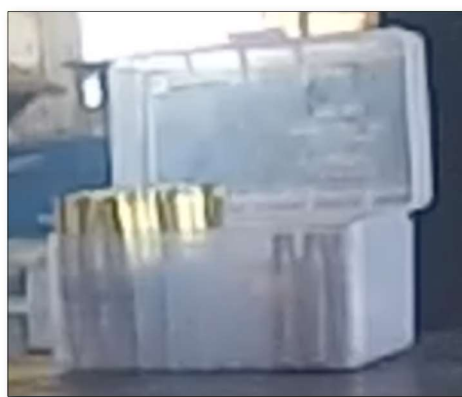
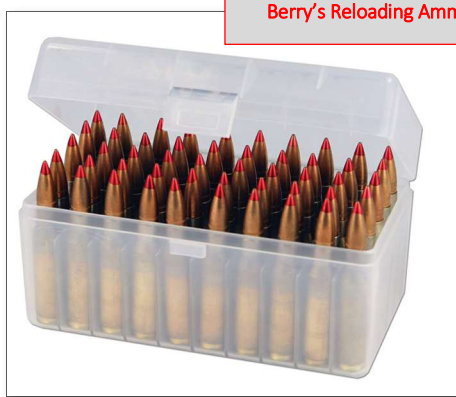
Figure 6.7: Mr. Batts Reloaders Ammo Box Compared to a Berry's 40903 Reloading Ammo Box

² Berry's is a plastics manufacturer which makes a wide variety of plastic products. Berry's supplies reloader ammo boxes to the firearms industry. My company, Atlas Development Group, uses Berry's boxes to ship our precision cartridge brass. Mr. Batts' reloader ammo box matches the Berry 40903 SKU. See Figure 6.7.

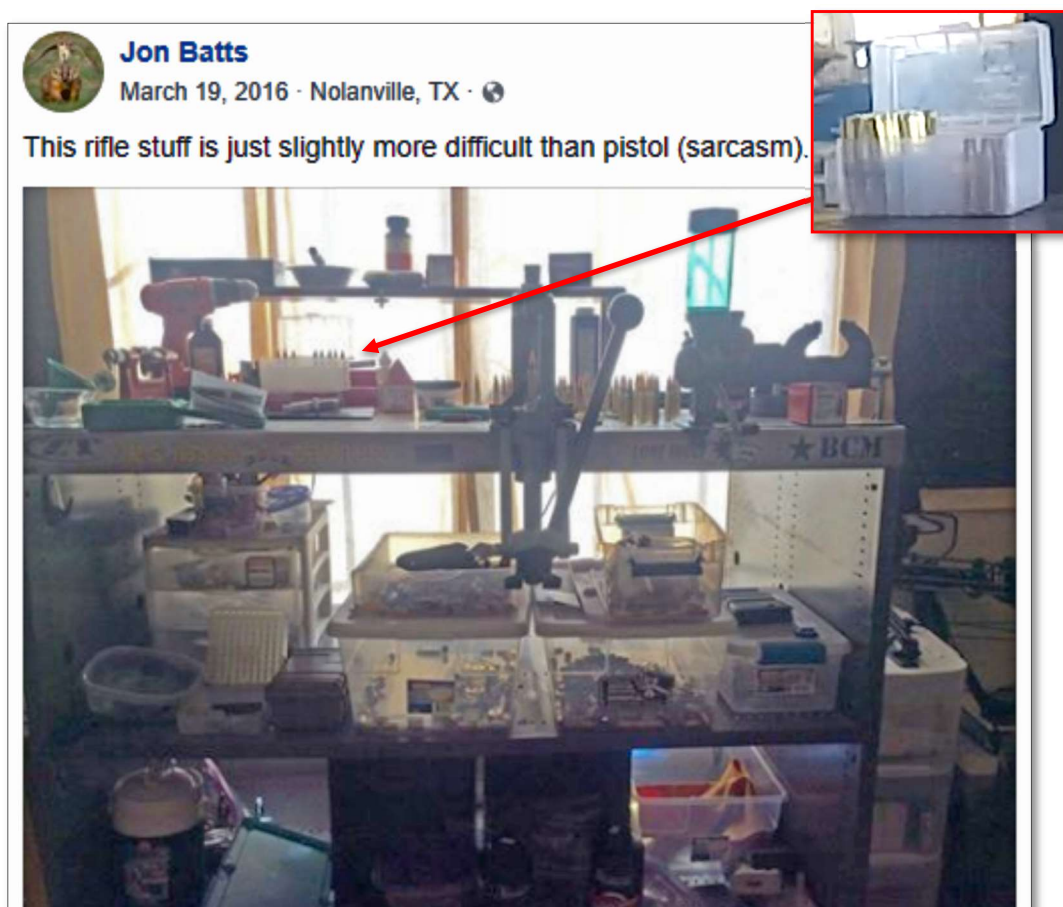
Figure 6.8: Mr. Batts Facebook Posting of Rifle Reloading Equipment and Loaded Cartridges.

Mr. Batts testified he had never hand loaded/reloaded rifle ammunition and that he only reloads pistol ammunition. Examination of Mr. Batts' Facebook post from March 19, 2016, shows an array of reloading equipment, reloading supplies, and loaded ammunition. The GPR5586 video shows Mr. Batts had saved discharged 308 Win shells in a reloading ammo box. Mr. Batts' posted Facebook photo also shows a reloading ammo box consistent with the one shown in the GPR5586 video. See Figure 6.8.

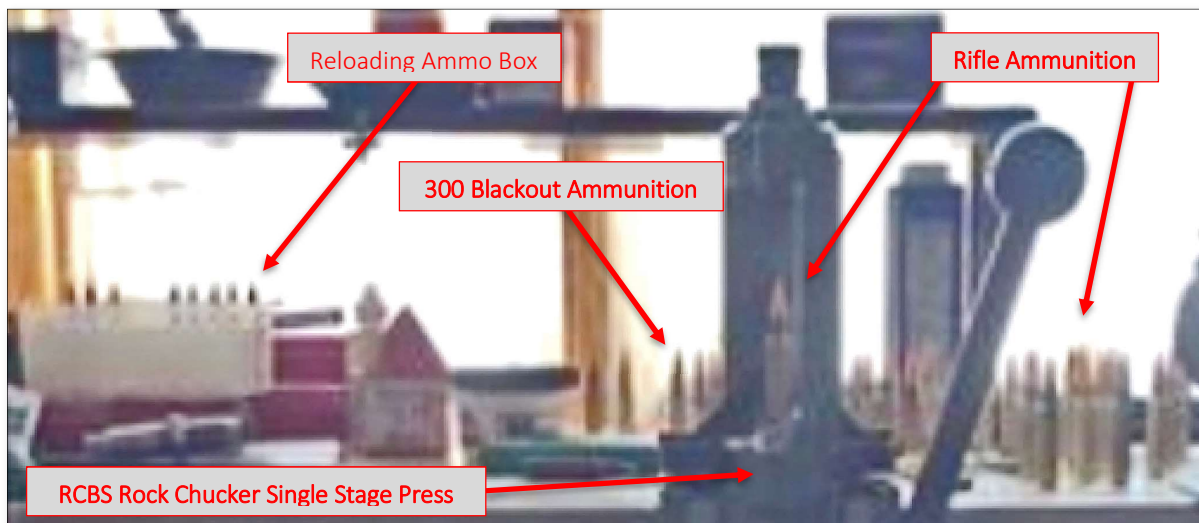
Figure 6.9: Enlarged View of Mr. Batts Facebook Photo on Rifle Ammunition Reloading

Interestingly, the title of Mr. Batts' posted Facebook photo is, "This rifle stuff is just slightly more difficult than pistol," with a rifle cartridge clearly visible in the single stage loading press (a RCBS Rock Chucker). See Figure 6.9. Examination of the ammunition to the left of the loading press indicates the bullet diameter appears to be close to the diameter of the shell. Given the cartridge geometry and the bullet shape, cartridges to the left of the presses are most probably 300 Blackout cartridges. If Mr. Batts does not reload rifle ammunition, it is unclear as to why he was saving the discharged rifle shells at the range and why his Facebook photos and comments indicate he reloads both pistol and rifle ammunition.

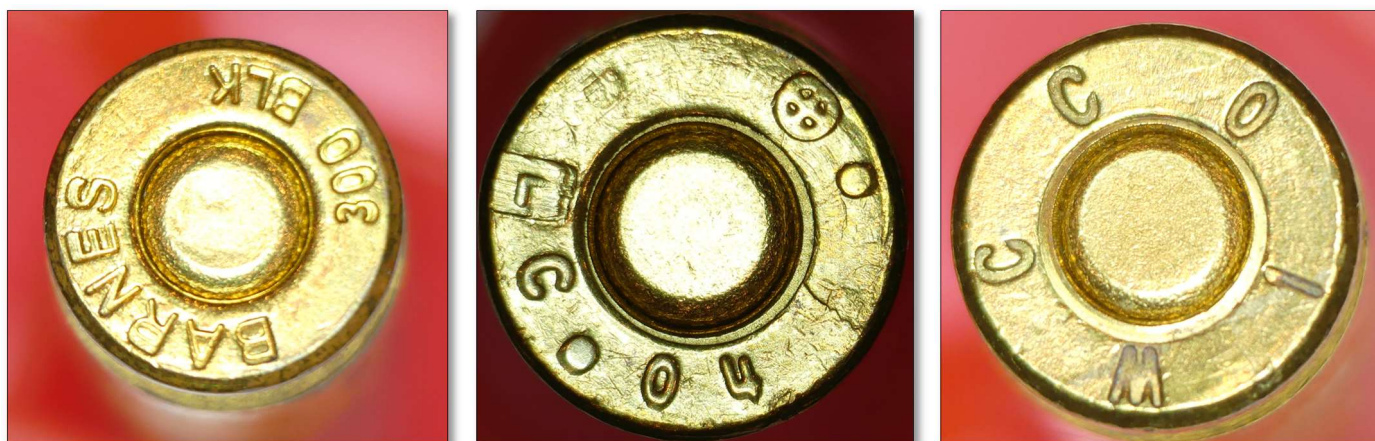
Per Mr. Batts' testimony, 17 rounds of ammunition should have been present for inspection. The three fired shells, including the incident shell were reportedly lost and unavailable for inspection. All of the unfired cartridges appeared to be 300 Blackout in caliber. Two of the cartridges used shell casings manufactured by Barnes bullets and were marked 300 BLK (the SAAMI approved cartridge marking for 300 AAC Blackout). Six of the cartridges used military shell casings manufactured by Winchester Cartridge Company and were originally 5.56mm NATO shells that had been resized to be 300 Blackout. One of the cartridges used a shell casing manufactured by Lake City Arsenal and was also originally a 5.56mm NATO shell that had been resized to a 300 Blackout. See Figure 8.1.2.

No crimp marks were observed on the mouth of both Barnes shells, which suggests they may be reloads (not factory). Both of the “Barnes” cartridges had open tipped bullets and weighed approximately 80 grains less than the other 7 cartridges, indicating the Barnes cartridges were supersonic and the remaining cartridges were subsonic. See Figure 8.1.3. Dimensionally, the overall cartridge lengths and shell lengths were within SAAMI limits. The shoulders of the Barnes shells were well formed, and the brass appeared to be in good condition.

to show the base to shoulder length was 0.005 inches above specification. The shoulder of a shell establishes the headspace for that shell. Use of the Lake City cartridge could exceed the headspace gap of a rifle's chamber and cause the rifle not to lockup when closed. The x-ray examination of the shoulder geometry showed it was not well formed and may not fit a SAAMI chamber properly. See Figure 8.1.4.

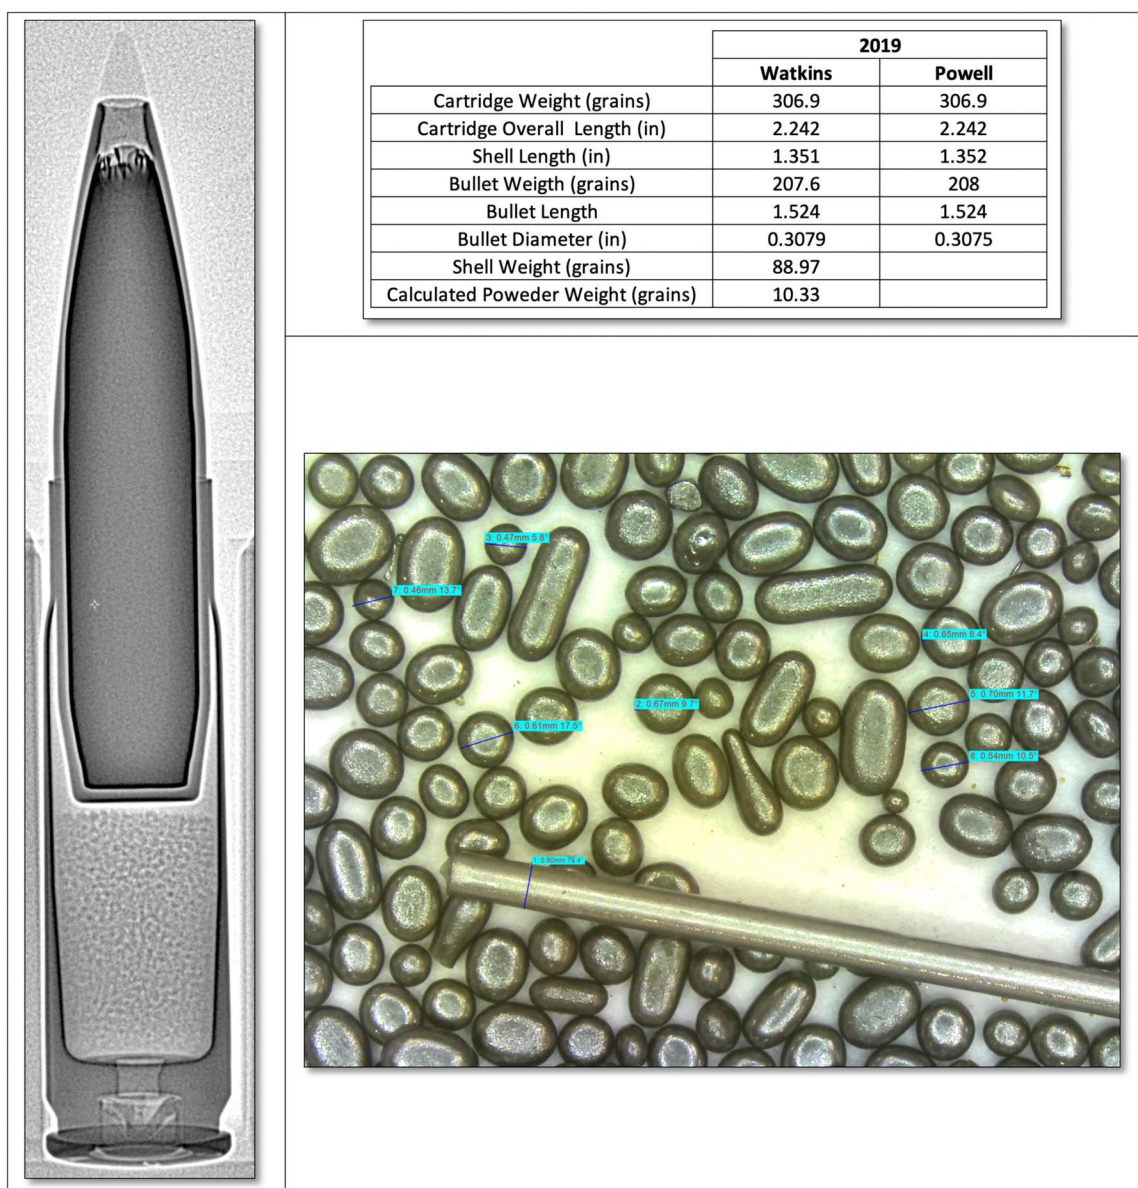
Figure 8.1.6: XXX

A kinetic bullet puller was employed to remove the bullet from cartridge #3 (Winchester shell). The bullet was difficult to pull, possibly over crimped. All aspects of the cartridge were measured, and the propellant was weighed to be 10.33 grains. The propellant was gray in color, did not contain color markers and consisted primarily of flattened balls/spheres with oblong granules intermixed. The dimensions of the granules were characterized optically via digital microscope. See Figure 8.1.6. Using the National Center for Forensic Science database of smokeless propellants, the propellant from cartridge three was identified to be substantially similar to the flattened sphere rifle propellants produced by Accurate™.
